NASA Technical Paper 1477

# Light Airplane Crash Tests at Three Roll Angles

Claude B. Castle and Emilio Alfaro-Bou

OCTOBER 1979

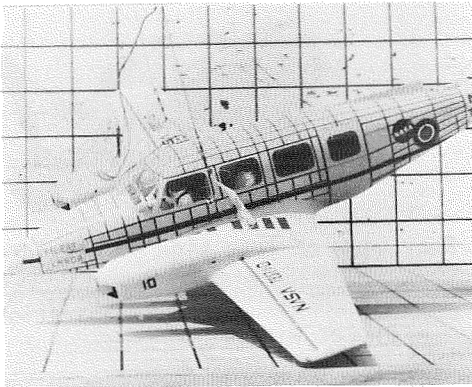
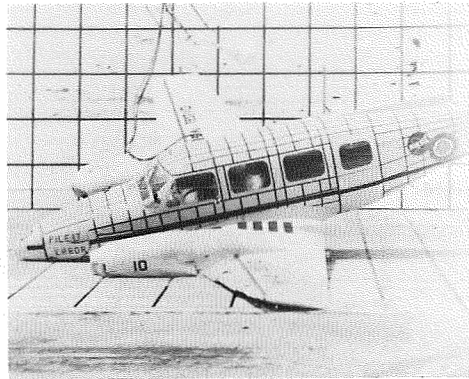
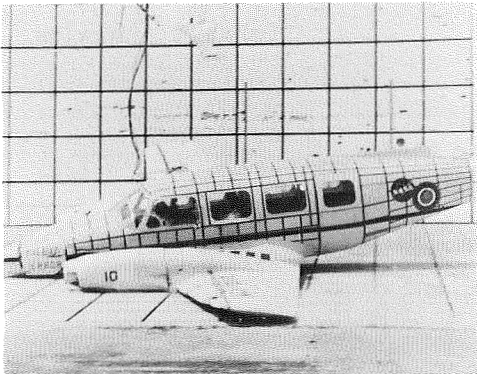
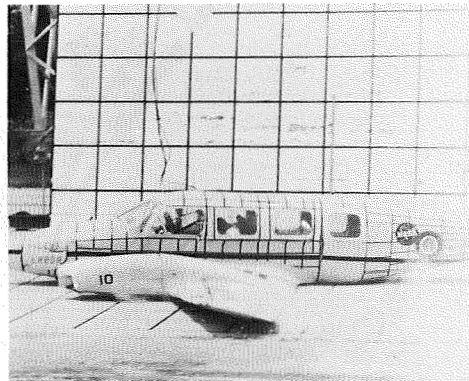
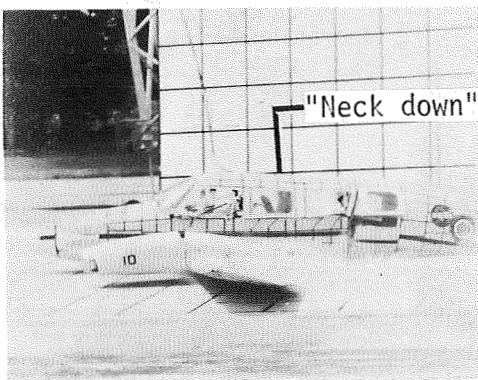
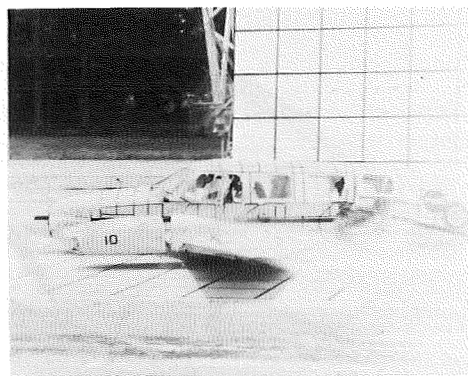
Figure 12.- Photographic sequence of  $-15^{\circ}$  roll test. L-79-295

Roll test at  $-15^\circ$ .— Sequence photographs of the airplane during a  $-15^\circ$  roll impact test are shown in figure 12. The photograph (fig. 12(a)) shows the cable separation and free-flight attitude prior to impact. Figure 12(b) (0.03 sec) shows the test airplane as the nose section contacts the impact surface and the left wing has impacted and begun to deform. In figure 12(c) (0.08 sec) the

fuselage in the vicinity of the fire wall has made contact, and the initial reaction of the dummy pilot and first-passenger dummy to the crash is evident. As the main fuselage contacts the impact surface (0.13 sec) and right wing, slapdown (0.18 sec, figs. 12(d) and 12(e)) has occurred, the pilot dummy impacts the instrument panel, and the fuselage has begun to separate along the window ledge on the left side of the test specimen; also, the door has started to open. In figures 12(e) and 12(f), as tail slapdown occurs (0.18 sec and 0.23 sec, respectively), the tensile loading in the top portion of the fuselage causes separation of the left and center windshield supports. This failure of the windshield supports then causes separation of the windshield and a rearward movement of the top portion of the cabin. These effects are shown by the misalignment of the painted black lines on the fuselage side representing the underlying structure. The top portion of the cabin in the vicinity of the first- and second-passenger dummies has begun to "neck down" and the first-passenger dummy has impacted the pilot seat. The engine cowling on the left side has sheared its rivets and separation has begun. Also shown is the window breakage along the left side.

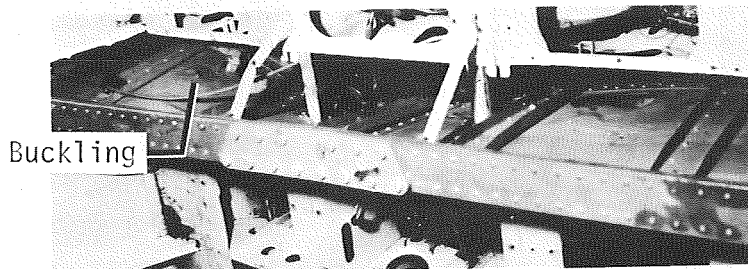
(c) Top view of main spar.

The damage done to the airplane interior in the  $-15^{\circ}$  roll test is shown in figure 14. A view looking forward in the cabin area (fig. 14(a)) shows only a slight apparently upward movement of the center floor area, as can be determined by the outward rotation of the accelerometer blocks. Figure 14(b) shows the forward cabin and cockpit area with fixtures removed. Also evident are slight apparently upward movement of the cabin floor center section and the separation of the cabin along the window ledge. The buckled left main spar near the main spar splice can be seen in figure 14(c), which is a top view of the main spar inside the cabin. A view of the floor support with small amounts of buckling of the cross-support structures is shown in figure 14(d). The torn and separated tail section shown in figure 14(e), in a view aft of the door, shows the effects of tail slapdown during impact.

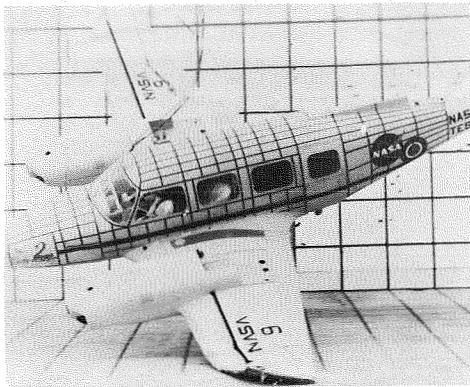
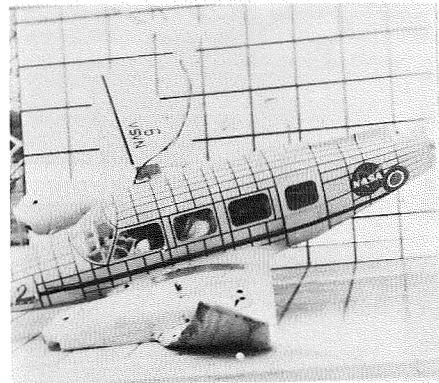
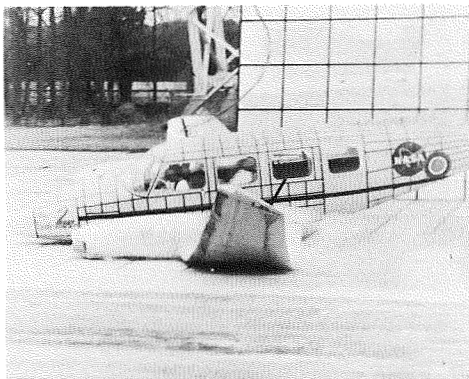
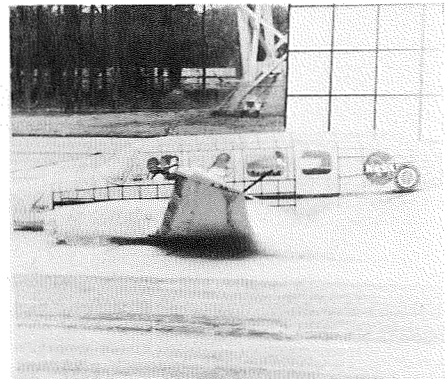
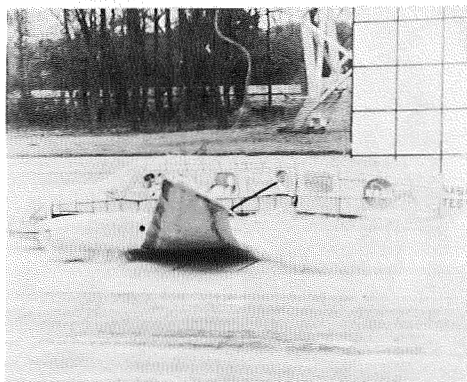
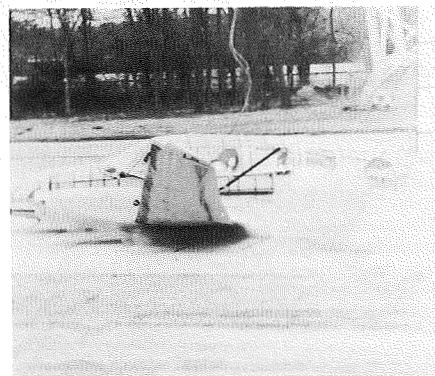
Figure 15.- Photographic sequence of  $-30^\circ$  roll test. L-79-298

Roll test at  $-30^{\circ}$ . The photographic sequence of the  $-30^{\circ}$  roll test is shown in figure 15. Wing deformation after initial impact is shown in figure 15(a). Figures 15(b) to 15(f) graphically illustrate how the left wing of the airplane bends during impact and attenuates some of the impact energy.

Movement of the pilot dummy has started and may be noted in figure 15(c). The airplane pivots about its left wing after initial impact for approximately 0.30 sec before right wing slapdown occurs. The resulting cabin deformation and slide out are shown in figures 15(d) to 15(f). It can be seen that the livable volume was maintained throughout the impact sequence.

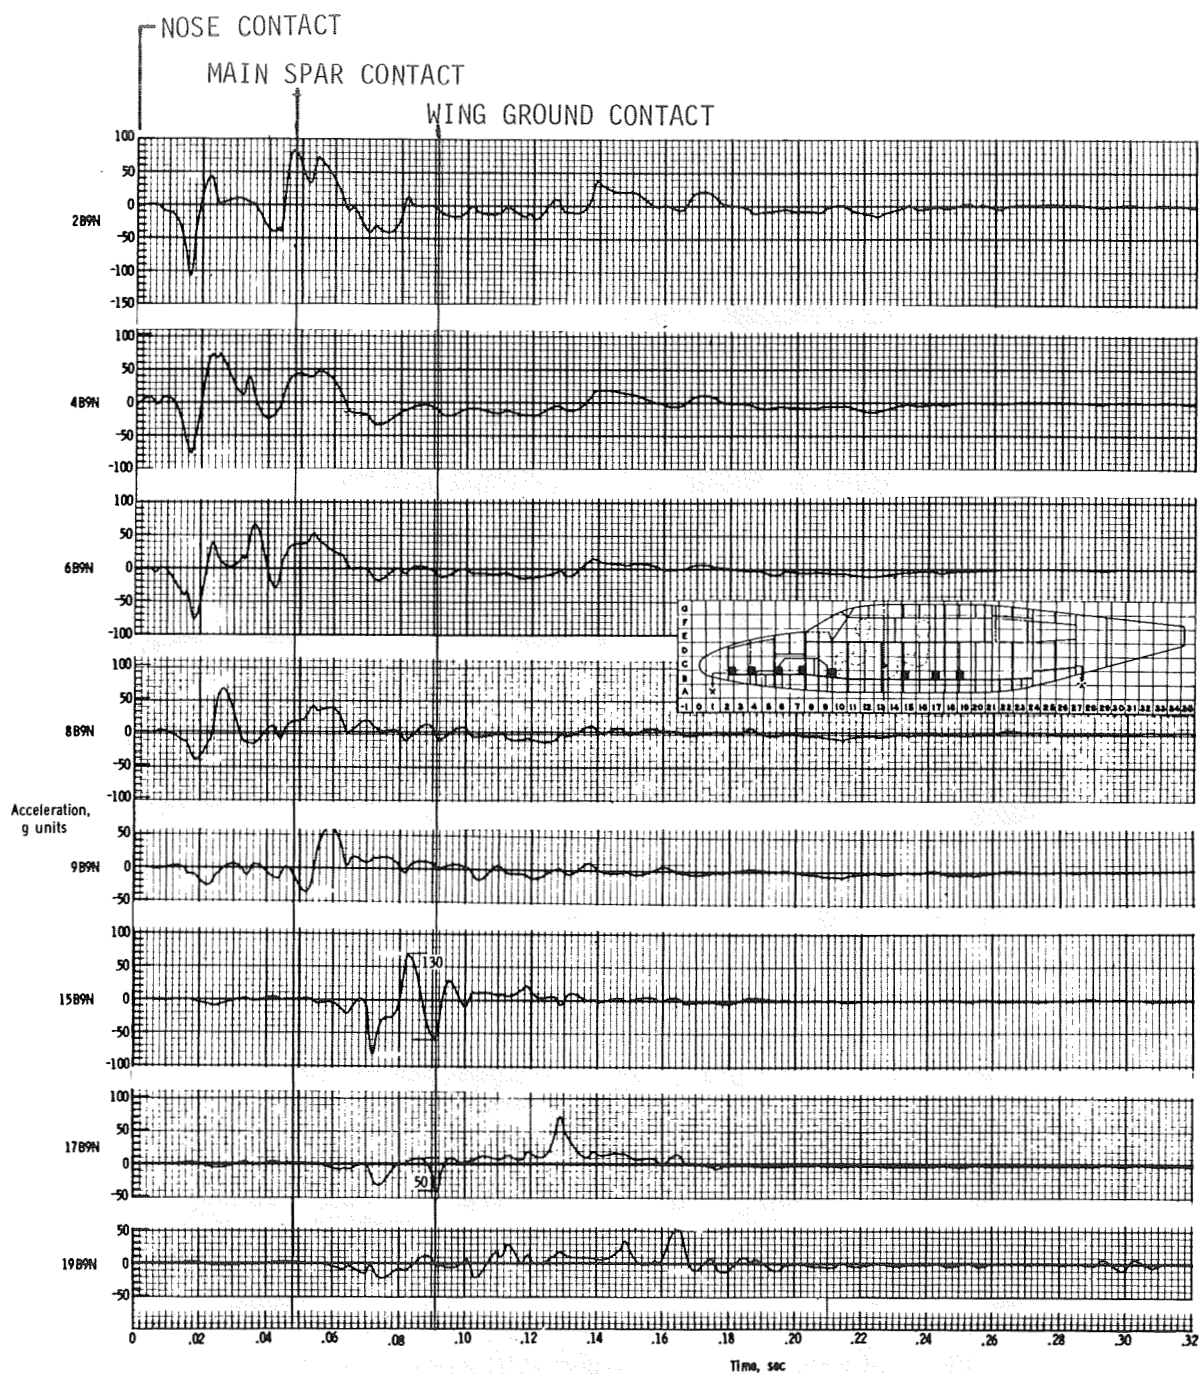
Figure 19.- Time histories of normal accelerations.

Roll test at  $0^{\circ}$ .— In figure 19(a), eight normal acceleration traces from the  $0^{\circ}$  roll test are presented, and the times of significant events are noted. The eight accelerometers were spaced along the left floor beam of the airplane (see insert, fig. 19(a) and fig. 8(a)) from the first nose frame (2B9N) to the door of the cabin (19B9N). Accelerations in the cabin compartment reached a maximum in the vicinity of the main spar and diminished progressively from that point rearward. At 0.091 sec (fig. 19(a)) the wing made ground contact and

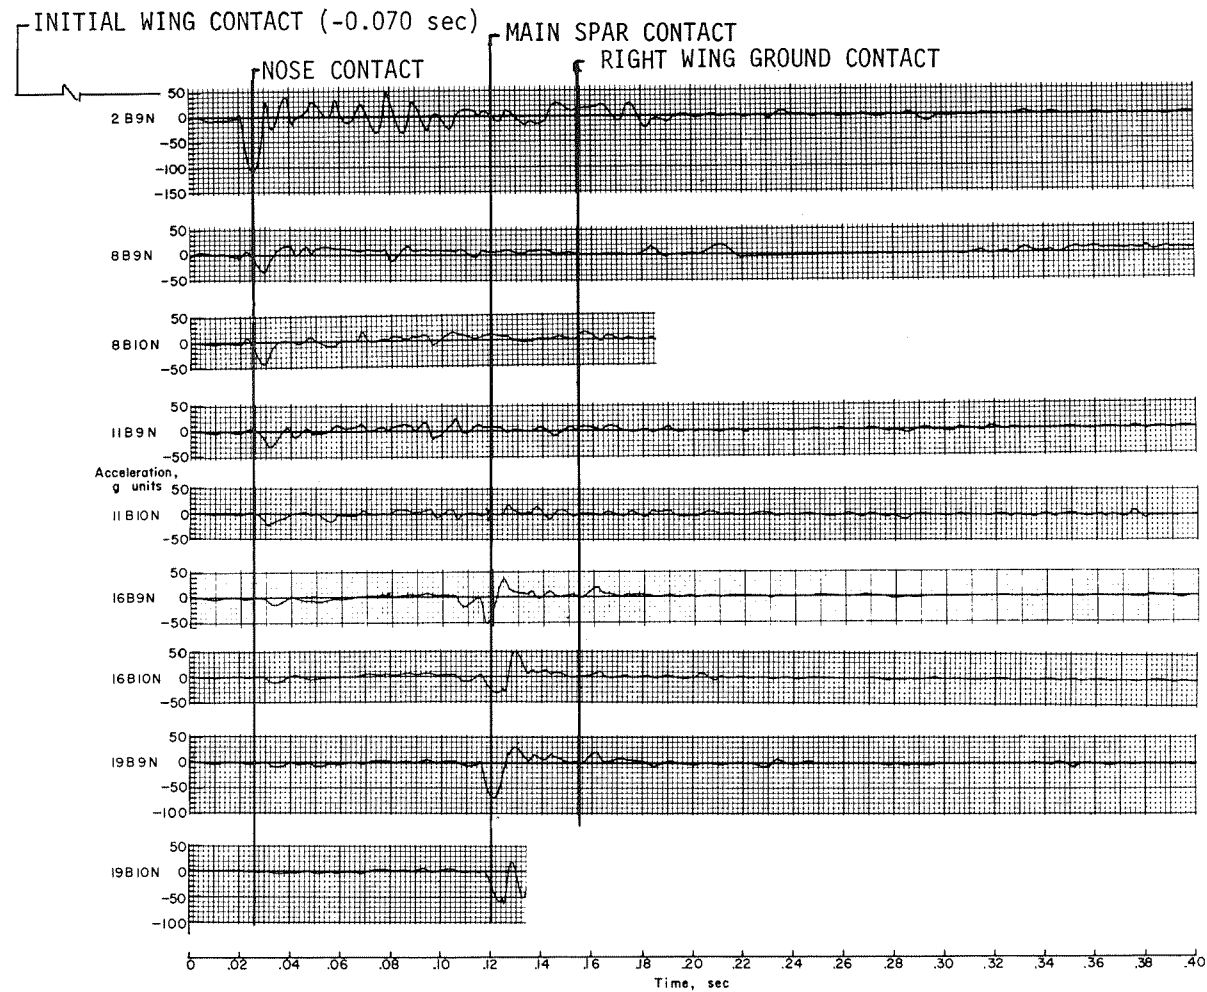
(b)  $-15^{\circ}$  test.

Roll test at  $-15^{\circ}$ . Nine normal acceleration traces along the floor structure are shown in figure 19(b) for the  $-15^{\circ}$  roll test. Only those five along the left floor beam are compared with the  $0^{\circ}$  roll test. Four additional accelerometers were added along the right floor beam for the  $-15^{\circ}$  and  $-30^{\circ}$  tests.

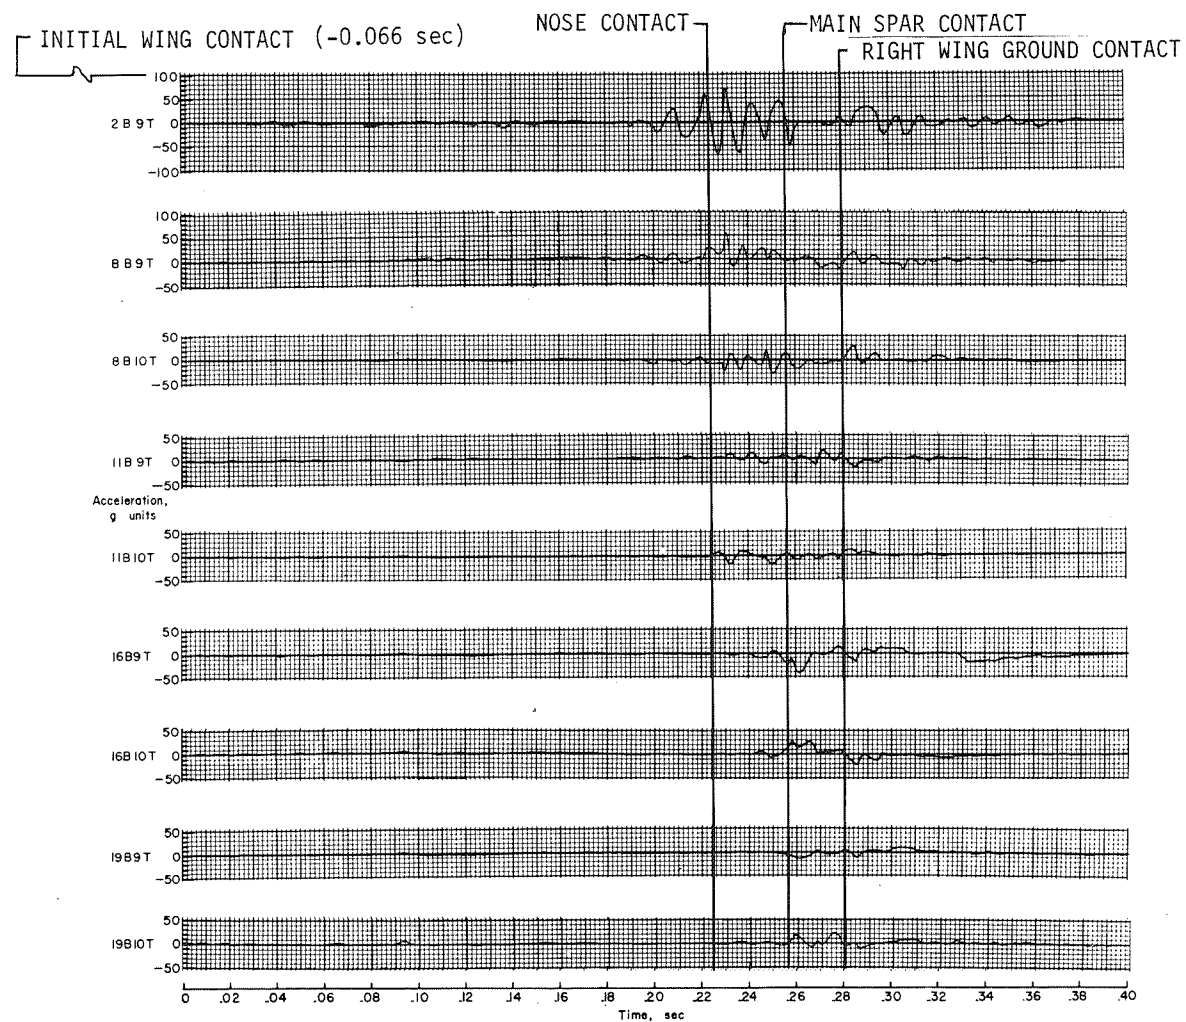
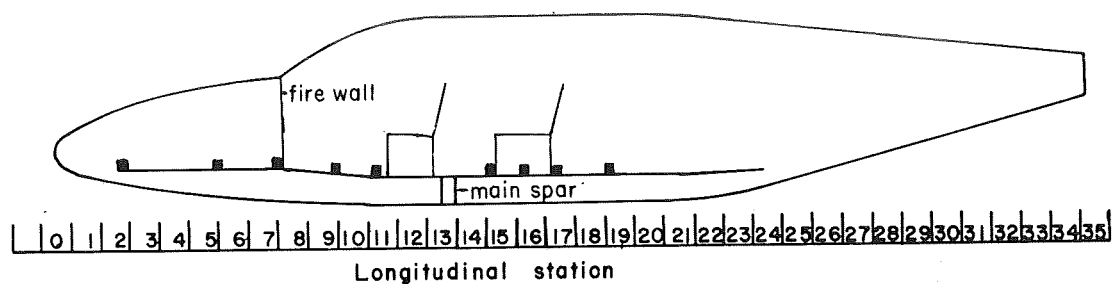
Figure 21.- Concluded.

Roll test at  $-30^\circ$ .- In figure 21(b), nine transverse acceleration traces are shown for the  $-30^\circ$  roll test and, in general, they show acceleration magnitudes similar to the  $-15^\circ$  roll test.

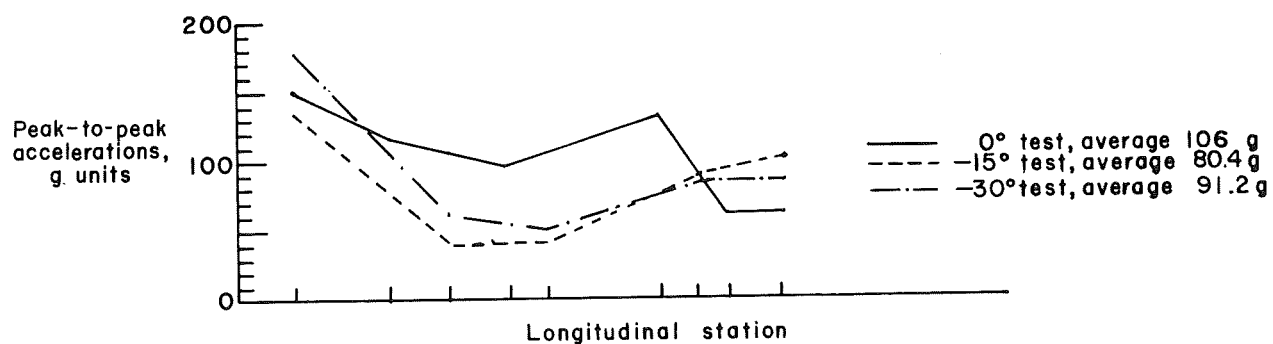
(a) Normal accelerations.

The average value of the highest peak-to-peak accelerations along the floor beam in the normal direction (fig. 22(a)) for the  $0^\circ$ ,  $-15^\circ$ , and  $-30^\circ$  roll tests is shown (fig. 22(a)) to be 106g, 80g, and 91g, respectively. In the longitudinal direction (fig. 22(b)), the average of the peak-to-peak acceleration values for the  $0^\circ$ ,  $-15^\circ$ , and  $-30^\circ$  roll tests was 47g, 43g, and 34g, respectively.

The profile of normal peak-to-peak accelerations in figure 22(a) indicates the effect of airplane roll on the floor structure accelerations during impact. The  $0^\circ$  roll test had the highest peak-to-peak acceleration pulses in the nose and in the vicinity of the main spar. The  $-15^\circ$  and  $-30^\circ$  roll tests had the highest normal peak-to-peak accelerations in the nose of the airplane. As opposed to the  $0^\circ$  roll test, however, the accelerations decreased from the nose to the vicinity of the cockpit; then they increased toward the aft portion of the airplane cabin.

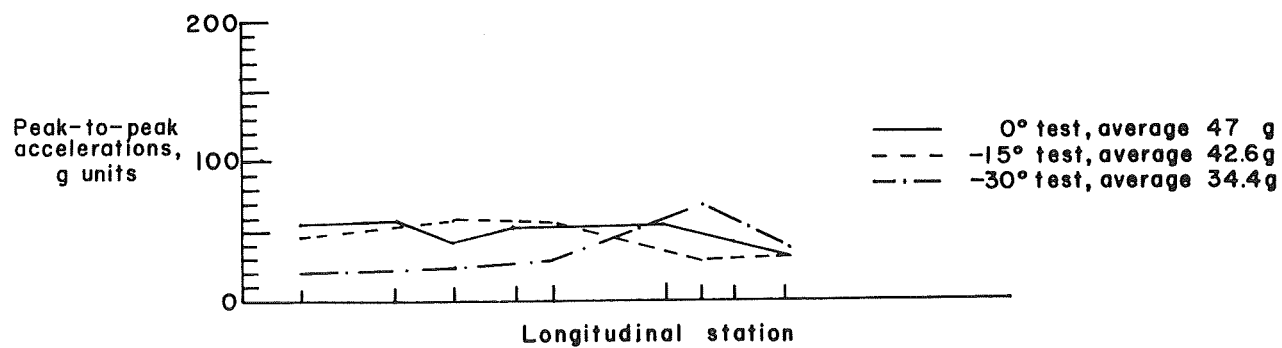
(b) Longitudinal accelerations.

As shown in figure 22(b), the  $0^\circ$  and  $-15^\circ$  roll tests had nearly constant longitudinal peak-to-peak acceleration profiles for the entire length of the floor beam.

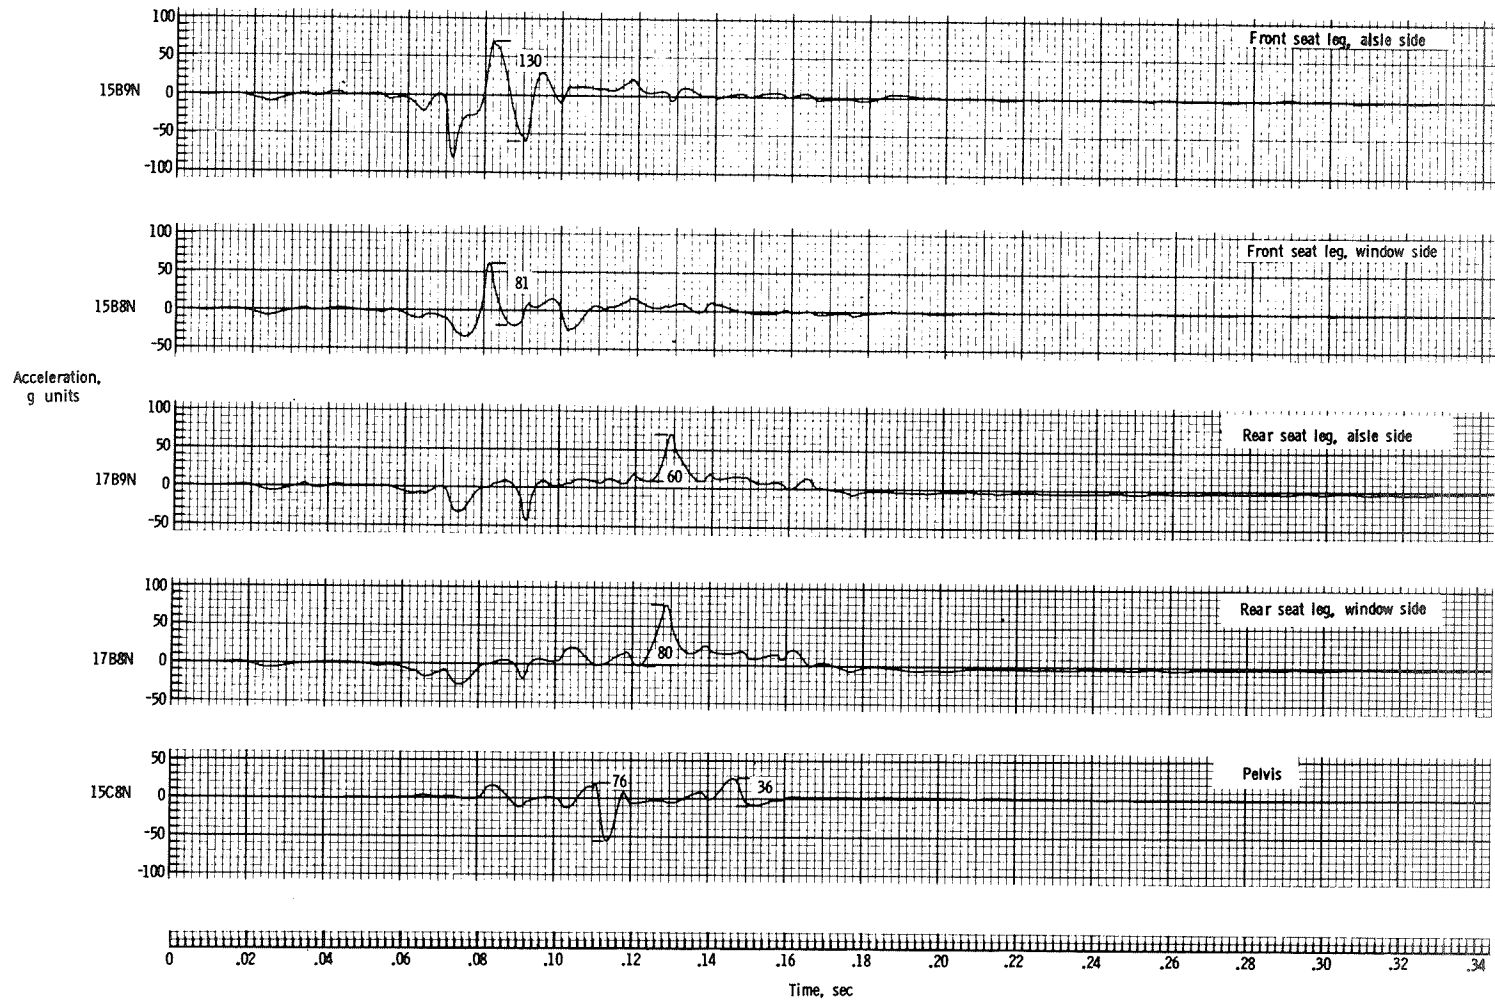
(a) 0° test.

Normal accelerations at 0° roll.- Figure 23(a) shows the normal accelerations for the 0° roll test specimen. Peak-to-peak accelerations of 130g and 81g were recorded on the floor under the two front seat legs at the first-passenger location, and accelerations of 76g were recorded in the pelvis approximately 0.024 sec later. The peak-to-peak accelerations on the floor under the rear seat legs were 60g and 80g. A 36g pulse on the pelvis occurred approximately 0.017 sec later.

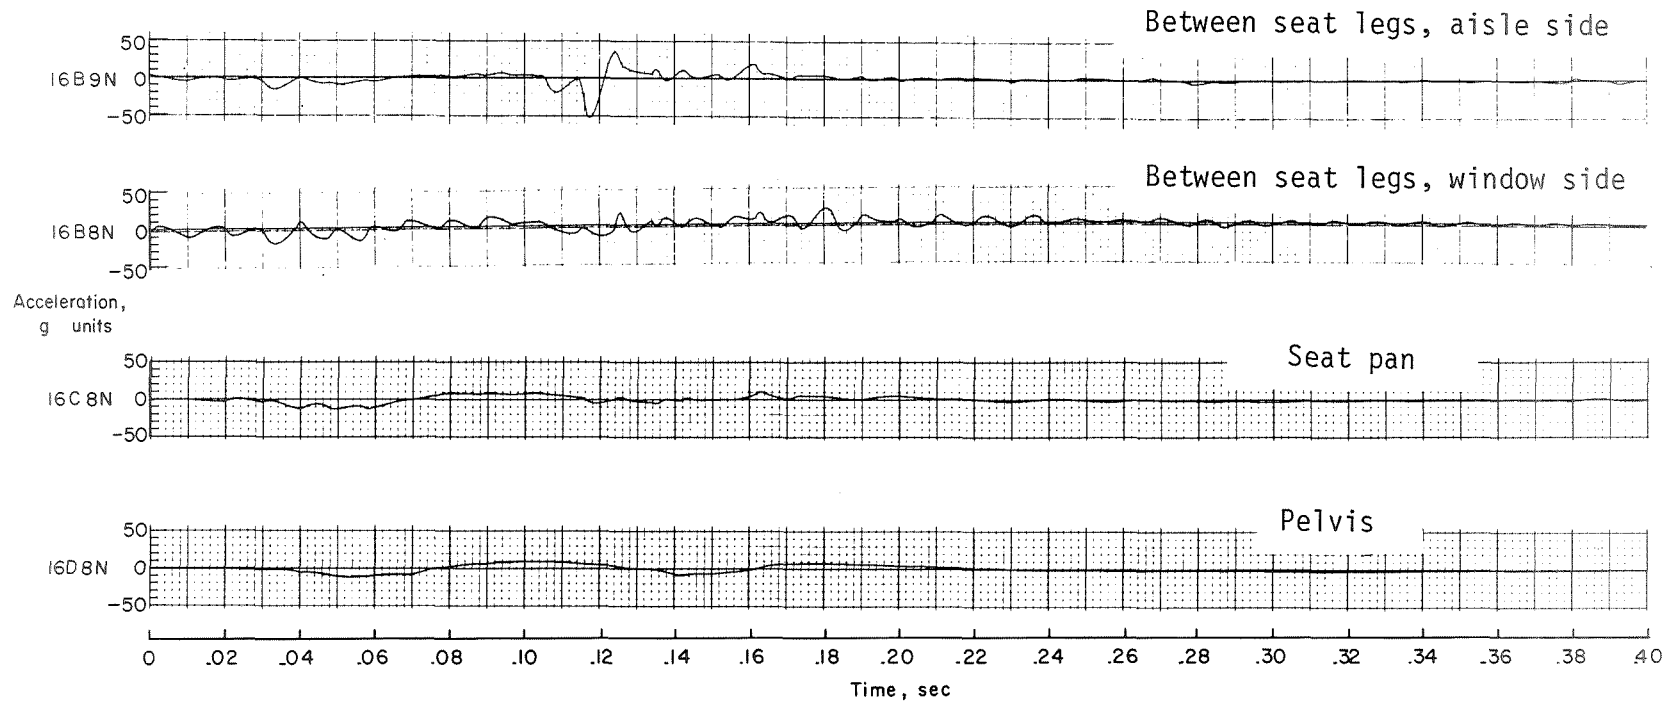
(b)  $-15^\circ$  test.

Normal accelerations at -15° roll.- The accelerations for the first-passenger seat, seat pan, and dummy pelvis are shown in figure 23(b). The accelerations on the seat pan and dummy pelvis show the reaction of the dummy to the impact of the nose section. Following wing impact, the dummy at the first-passenger position was forced toward the left window and then back into an upright position. This uprighting was associated with a 10g pulse on both the pelvis and seat pan (0.04 sec). During fuselage main spar contact, a positive 10g pulse caused the dummy to rebound and lift up on the seat. The primary input to the seat occurred at fuselage main spar contact (0.12 sec).

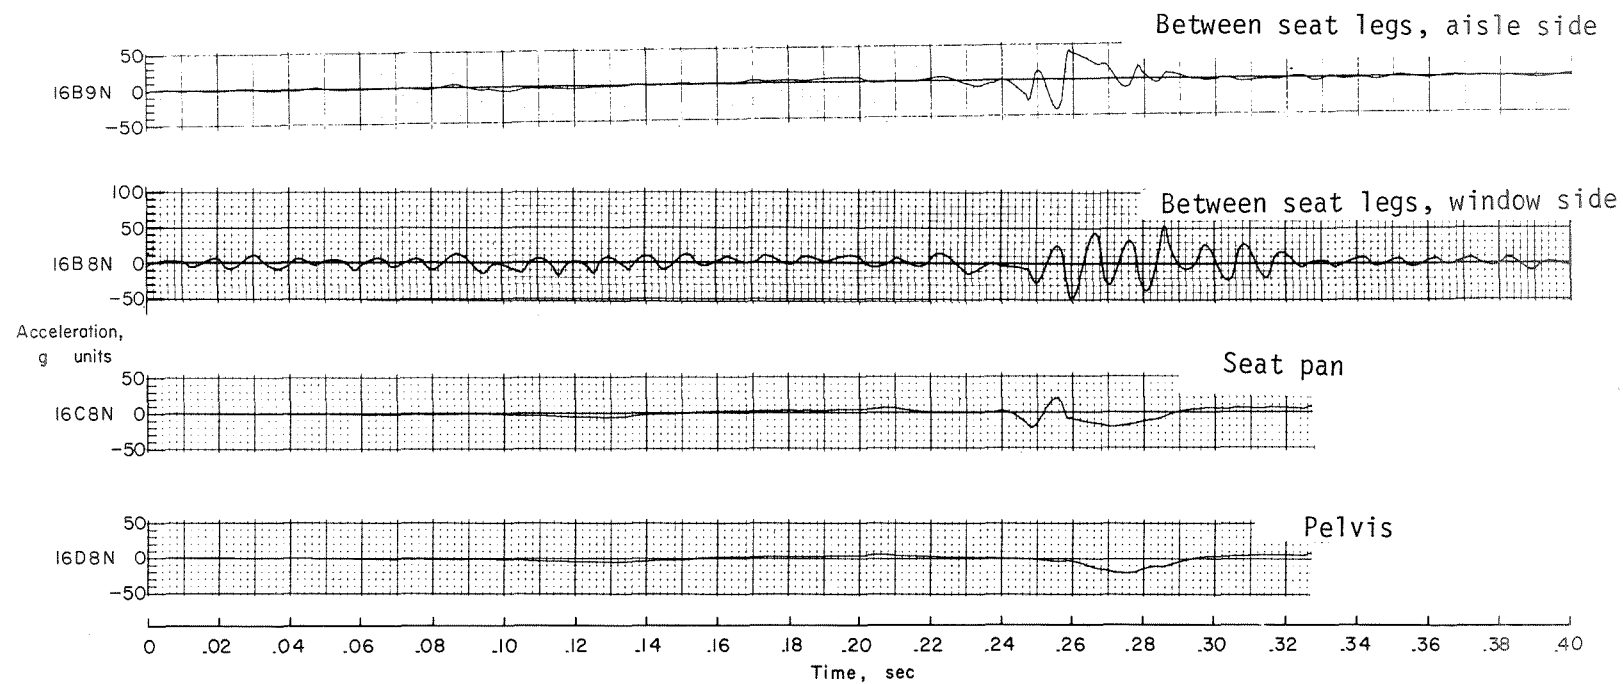
(c)  $-30^\circ$  test.

Normal accelerations at -30° roll.- Accelerations for the floor under the first-passenger seat, seat pan, and dummy pelvis for the -30° roll test specimen are shown in figure 23(c). The accelerometer on the window side of the first-passenger seat shows the same oscillatory motion as in the -15° roll test resulting from the loading of the wing aft attachment to the fuselage. Accelerations on the aisle side are low during the wing skid time as a result of the deformation and failure of the wing structure (see fig. 18), which resulted in discontinuities and less transmission of forces to the fuselage. As the fuselage at the main spar location contacts the impact surface, accelerations of about -40g and -50g on the floor under the aisle and window side seats are reflected as a pulse of approximately 20g on the seat pan at about the same time. The dummy pelvis acceleration also was approximately 20g. As in the -15° roll test specimen, the small reversing of the acceleration traces on the seat pan and dummy pelvis prior to nose contact is associated with the uprighting of the dummy in its seat. Normal accelerations on the floor at the first-passenger location and at the dummy's pelvis were highest for the 0° roll test and lowest for the -15° roll test. It should be noted that piezoelectric accelerometers were used in the dummy pelvis for the 0° roll test, whereas strain-gage accelerometers were used for the -15° and -30° roll tests.

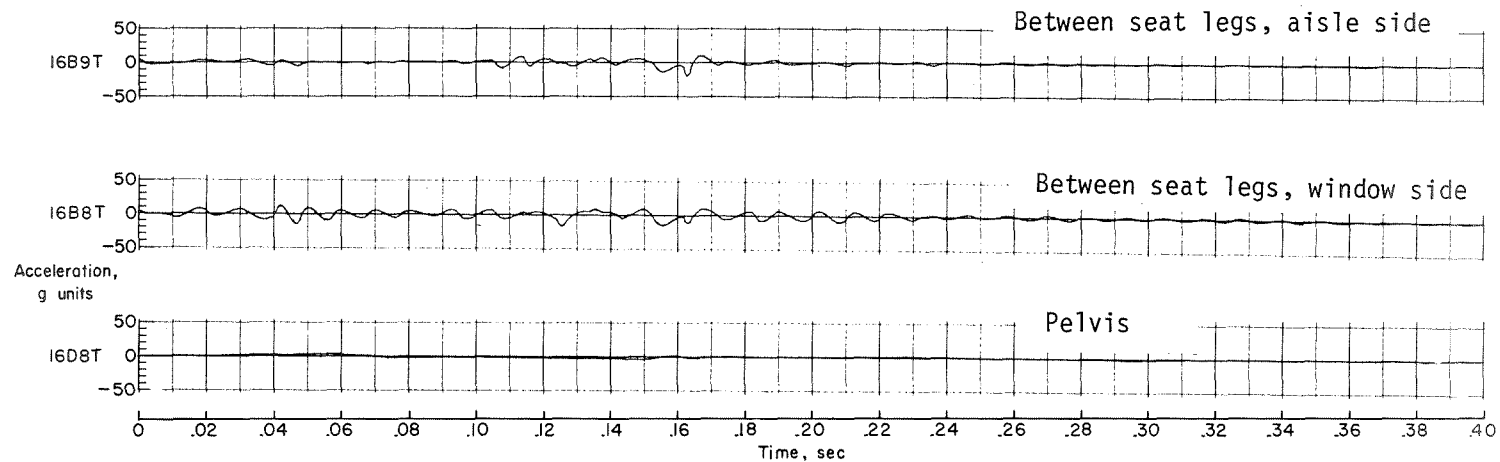
(a)  $-15^{\circ}$  test.

Transverse accelerations at  $-15^{\circ}$  and  $-30^{\circ}$  roll.- The transverse acceleration time histories are presented in figure 25 for the  $-15^{\circ}$  and  $-30^{\circ}$  roll test specimens. The accelerometers were mounted in the dummy pelvis and on the floor beam midway between the aisle-seat legs and on the frame midway between the two window-seat legs. There were no transverse accelerometers for the  $0^{\circ}$  roll test specimen for the first-passenger location.

Transverse accelerations for the  $-15^{\circ}$  and  $-30^{\circ}$  roll tests (figs. 25(a) and 25(b)) were generally below 50g at both floor locations when the right wing of the airplane slammed onto the impact surface. Response to the impact at the dummy's pelvis was an acceleration pulse of about 5g for both tests.
